Case 255 : Narrative

Case Vehicle (A): 1998 Chevrolet
Type: Malibu LS, 4-door sedan
Driver: 57-year-old male
CDC: 12-FDEW-1

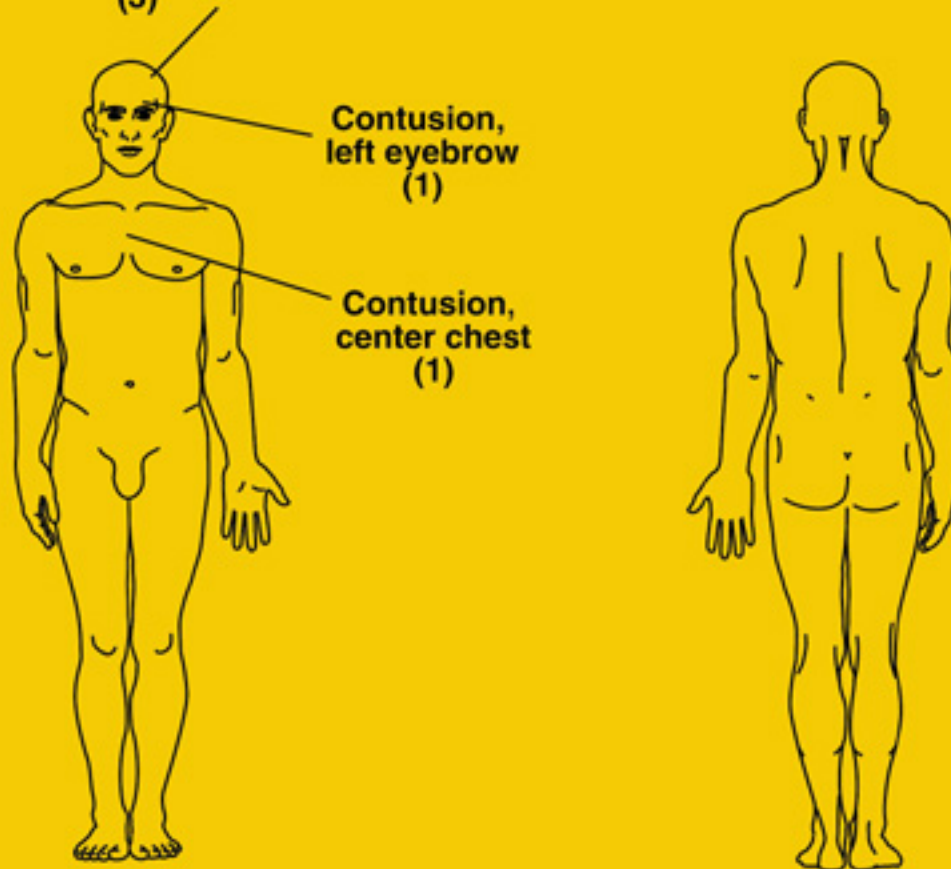
Unconscious on initial observation at scene, less than one hour, GCS of 13 on admission, with neurological deficit (3)

SEVERITY: MAIS - 3 : ISS - 10

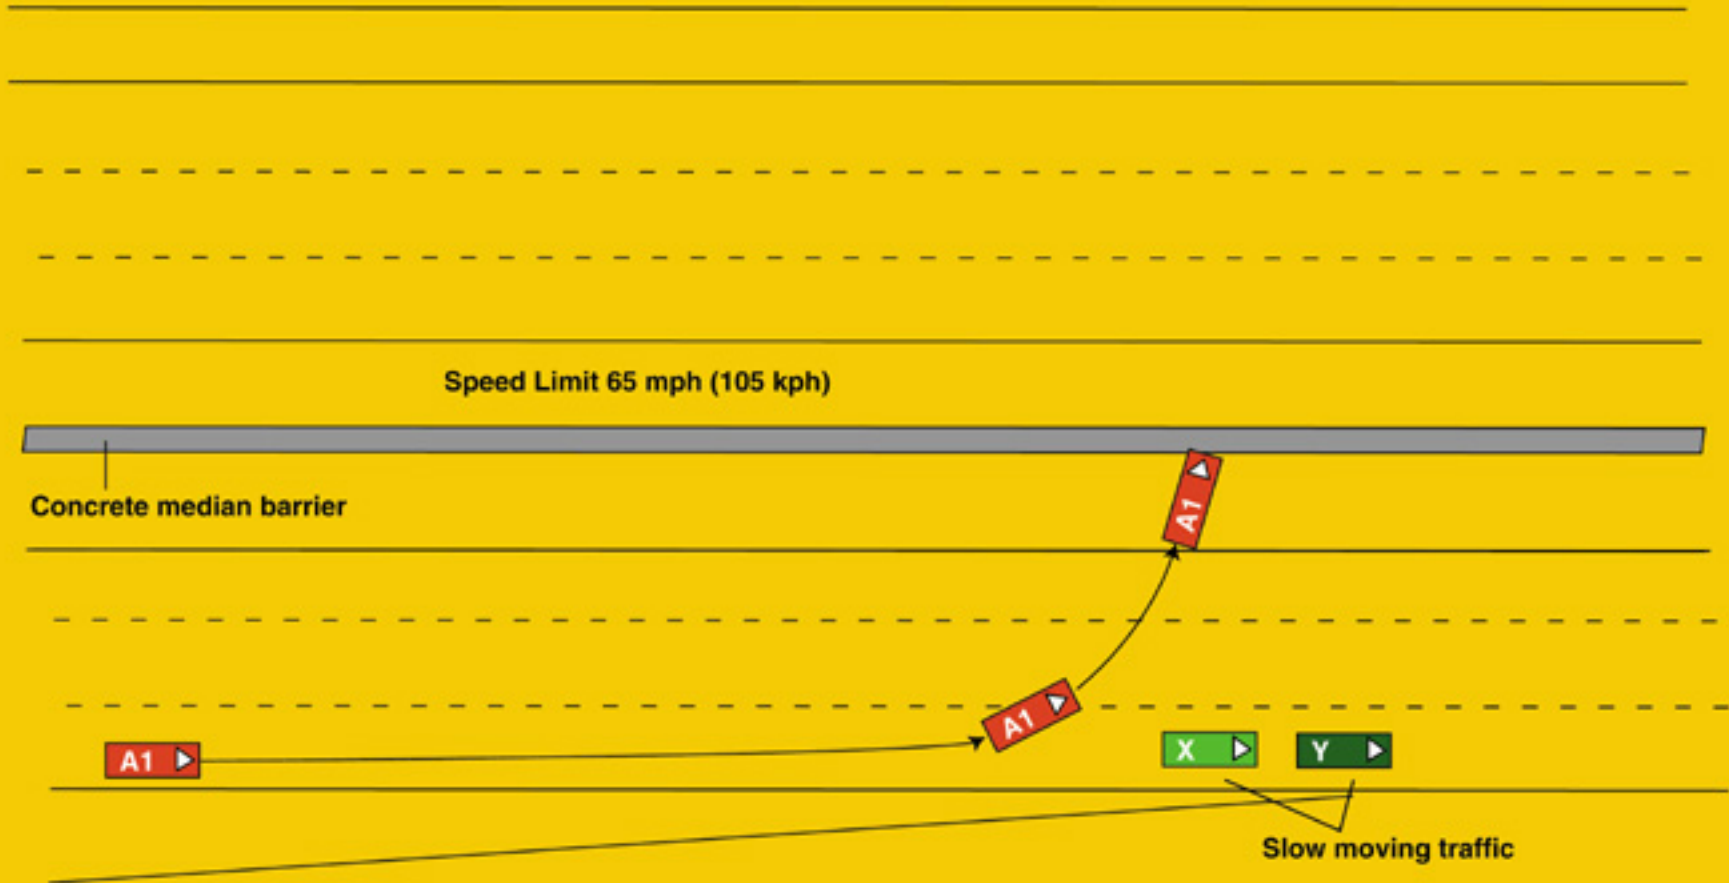
[1](#) It was daytime, the sky was clear, and the road surface was dry and free of defects when case vehicle (A) was traveling east at an unknown speed in the right throughlane of a divided, multi-lane, limited-access, concrete freeway. [2](#) When traffic slowed in front of case vehicle (A), the driver reportedly steered hard to the left and the vehicle crossed the other two eastbound lanes and struck the concrete median barrier with its left front. The driver was transported by ambulance to a local hospital and was hospitalized for 25 days. Case vehicle (A) was towed due to damage.

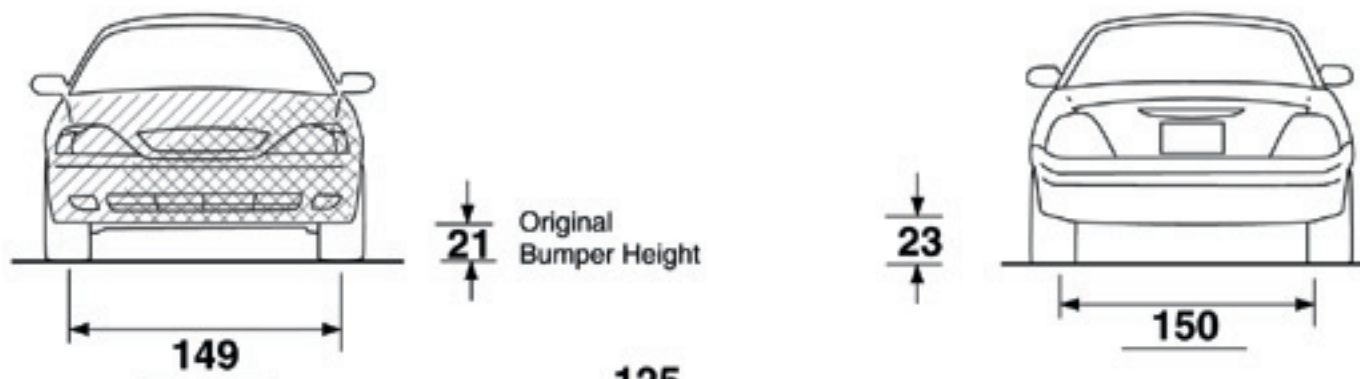
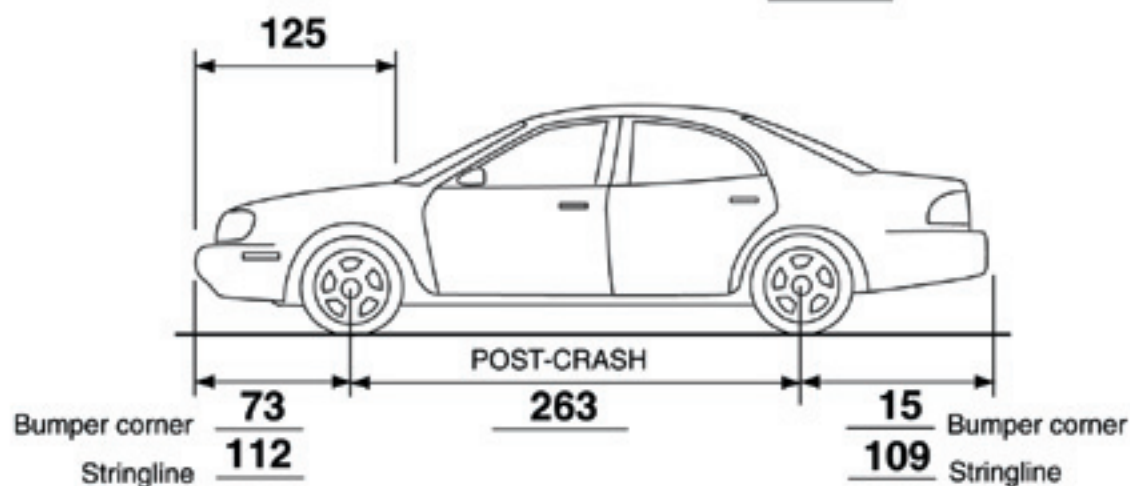
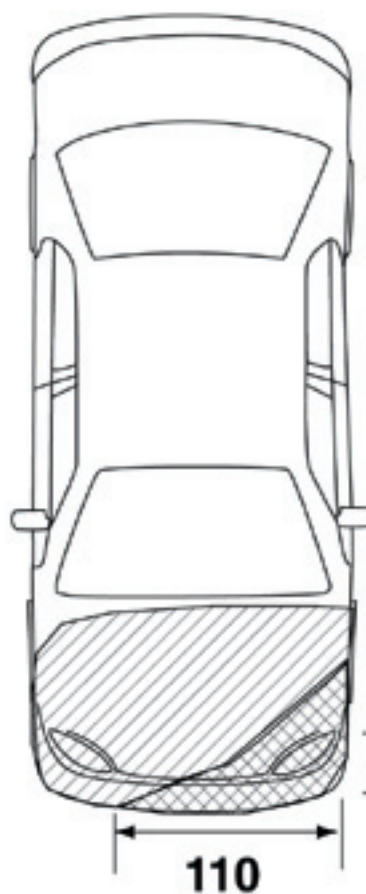
MEASUREMENTS IN CENTIMETERS

Max. crush to left front bumper corner

25

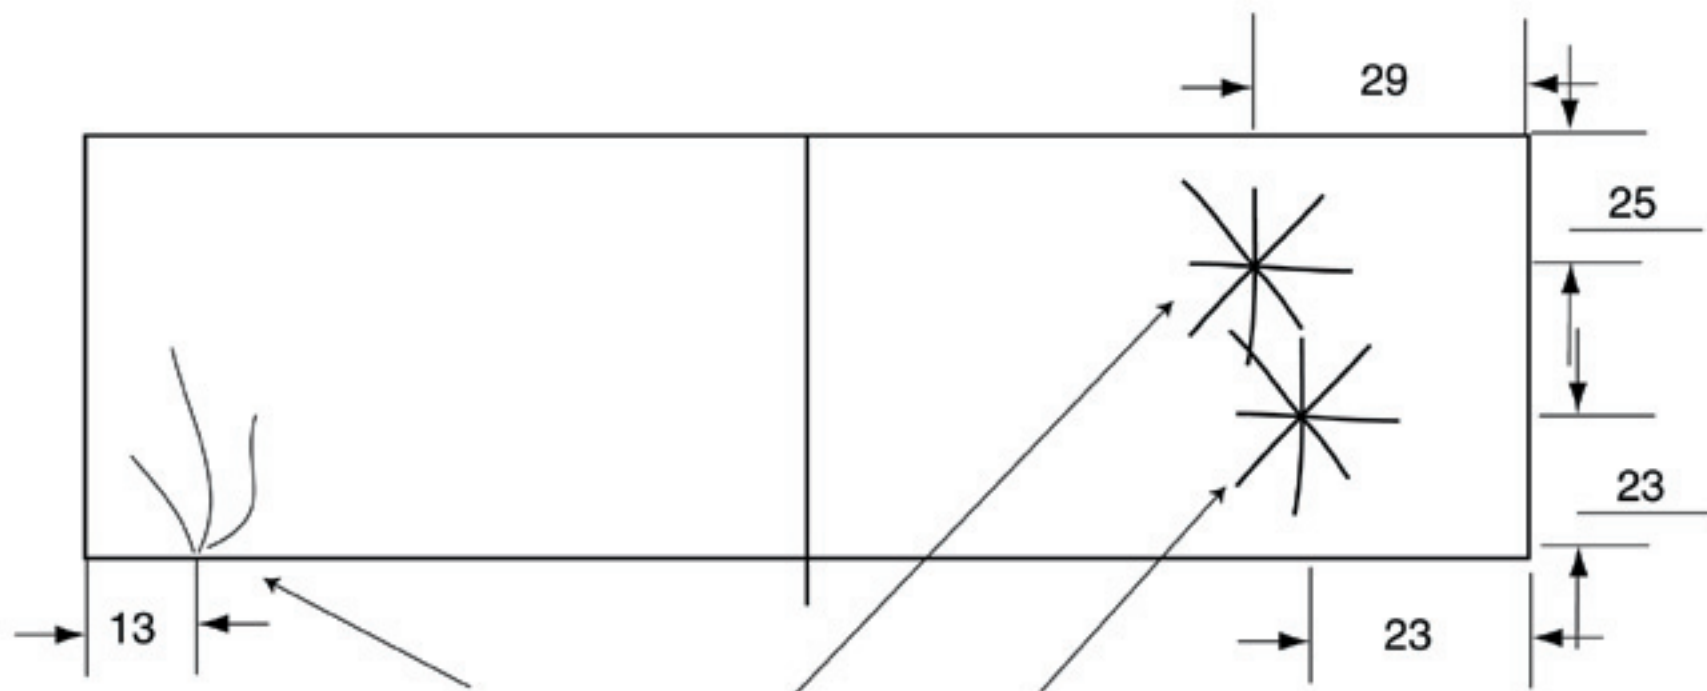
WINDSHIELD MARK ON CASE VEHICLE:

cracked due to left hood hinge, driver and passenger airbag flap contact

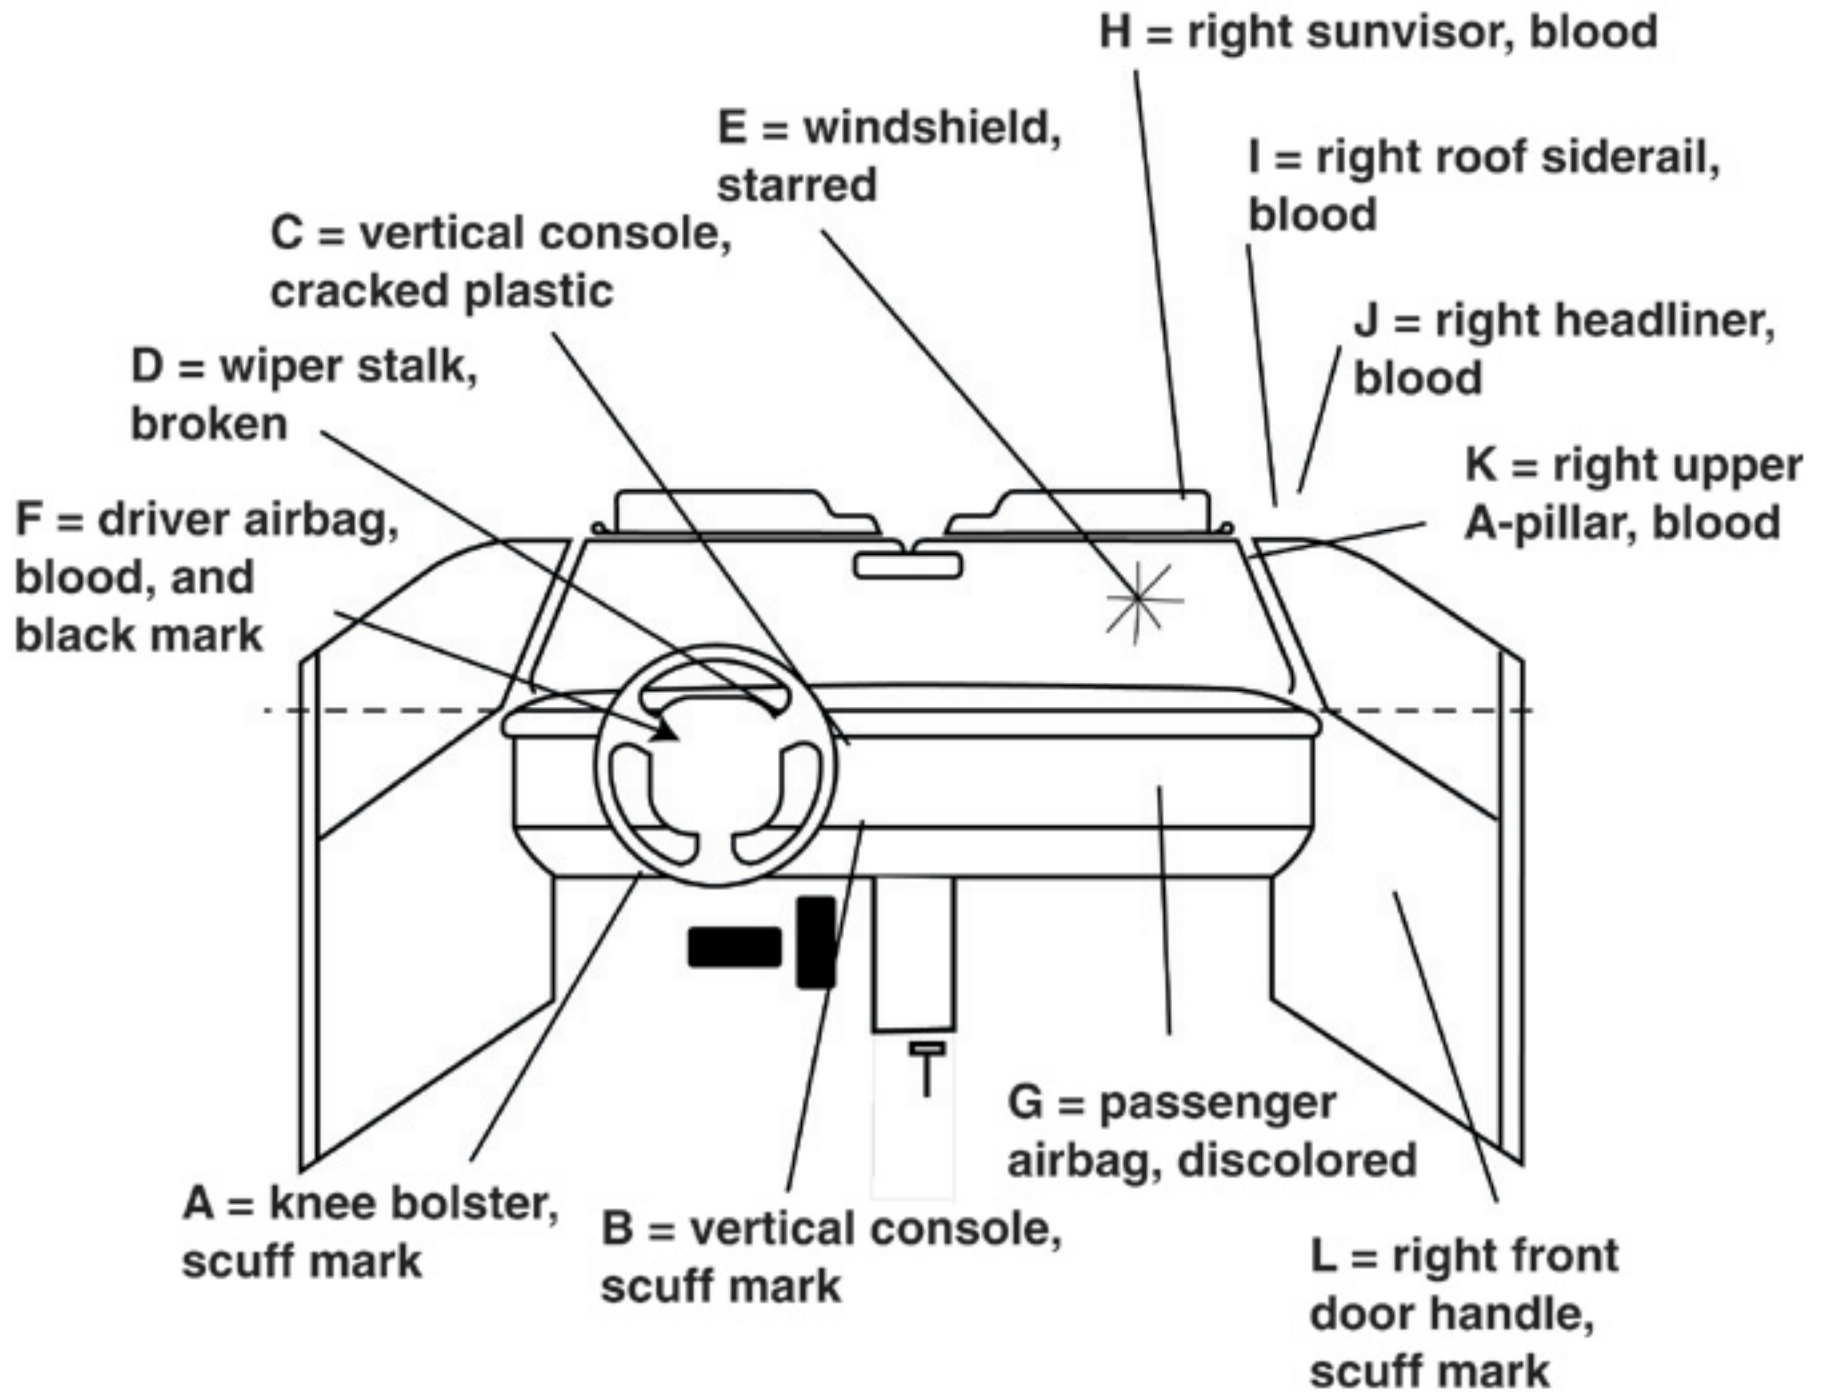
OCCUPANT CONTACT WORKSHEET

Contact	Interior Component Contacted	Occupant No. if Known	Body Region if Known	Supporting Physical Evidence	Confidence Level of Contact Point
A	Knee bolster	Dr	Lt. knee	scuff	1
B	Vertical console	Dr	Rt. knee	scuff	1
C	Vertical console	Dr	Chest	cracked plastic	1
D	Wiper stalk	Dr	Face	Broken	1
E	Windshield	Dr	Head	Starred	2
F	Driver airbag	Dr	Head	Blood	3
G	Passenger airbag	Dr	Head	Discolored	3
H	Right sunvisor	Dr	Unknown	Blood	3
I	Right roof siderail	Dr	Unknown	Blood	3
J	Right headliner	Dr	Unknown	Blood	3
K	Right upper A-pillar	Dr	Unknown	Blood	3
L	Right front door handle	Dr	Unknown	Scuff	1
